July 22, 2010

Windsor, Ontario parking garage collapse demonstrates need for shoring

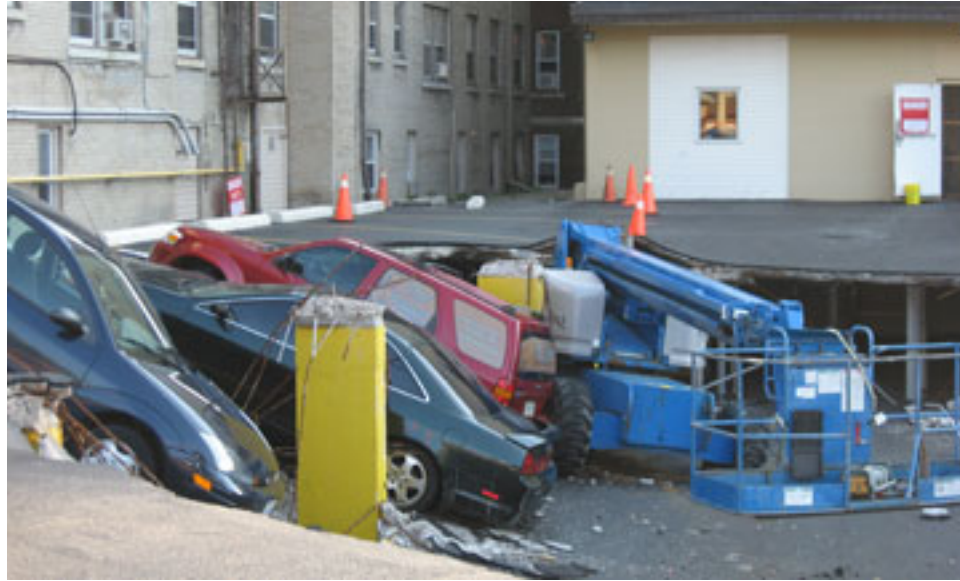
Excess loading from a boom truck may have contributed to the collapse of a Windsor, Ont. parking garage.

Cody was speaking in the wake of a small parking garage collapse in Windsor July 8, apparently caused by excess weight from a zoom boom truck. This was in addition to an extra layer of asphalt applied to the street level surface of the garage at some point in the past, which had weakened it.

Windsor engineer Norm Becker, hired by the garage's owner, Romalist Developments Ltd. to investigate the collapse, said the "dead weight" from asphalt resurfacing done some years ago contributed to the failure.

The boom weighed about 22,000 pounds. The collapse occurred in the southern half of the lot.

Cody said garage levels or floors should therefore be reinforced by using post shores and shoring frames.
